HYDRAULIC SYSTEMS

Extensión de vida útil para componentes a través de nuevas tecnologías de metalización - HVOF

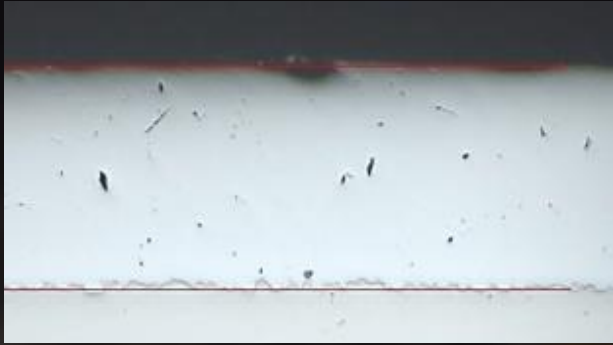
C R O M O E

CAPA DE CROMO 15 MILÉSIMAS

Microhardneses hv 0,3	Wear Rate	Temperature (°C)
800 – 1000	1	430

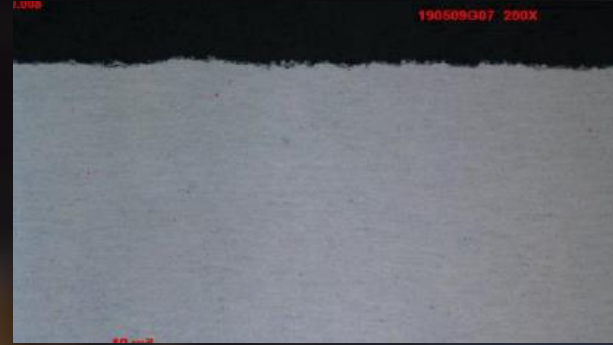
C A R B U R O (H V O F)

CAPA DE 86WC/10CO/4CR 15 MILÉSIMAS

Microhardneses HV 0,3	Wear Rate	Temperature (°C)
1100 - 1400	0,2	540
900 - 1200	0,4	850

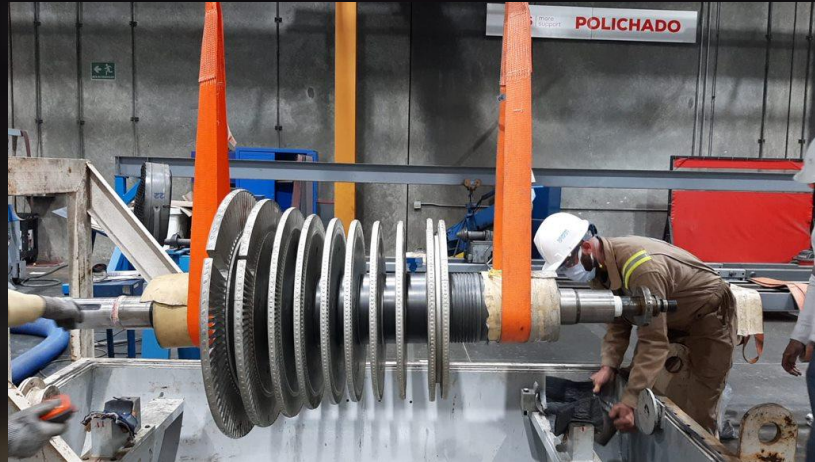
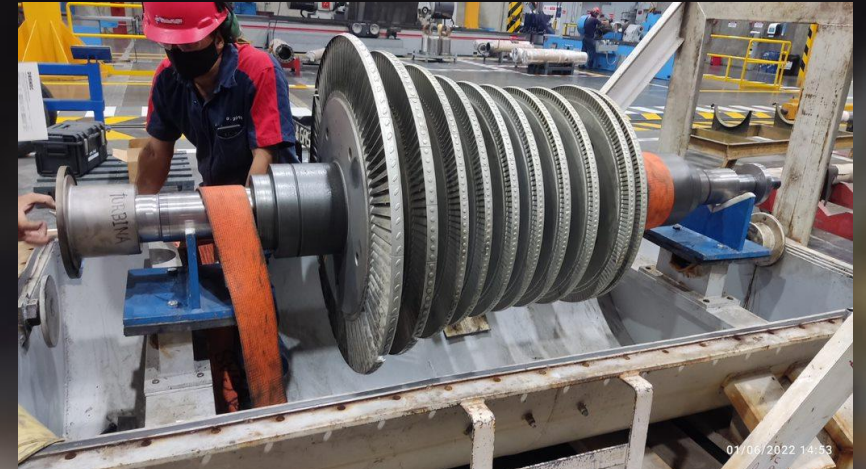
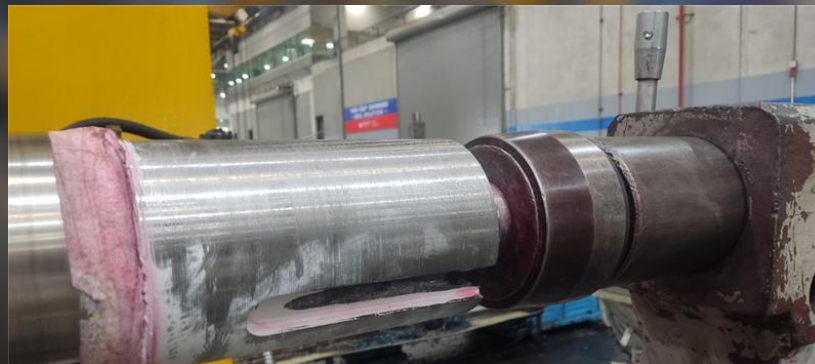
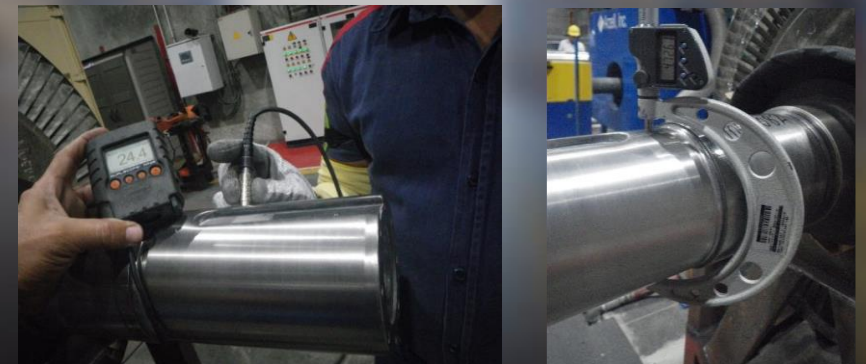
Extensión de Vida de los Componentes (Siemens-Ecopetrol)

COMPONENTE

Turbina de Gas

**ESPESOR DE
SALVAMENTO**

560 Micrones

REVESTIMIENTO

75 CrC – 25 NiCr
0,7% porosidad
11.000 psi adhesión
1.100 VH

A N T E S

D E S P U E S

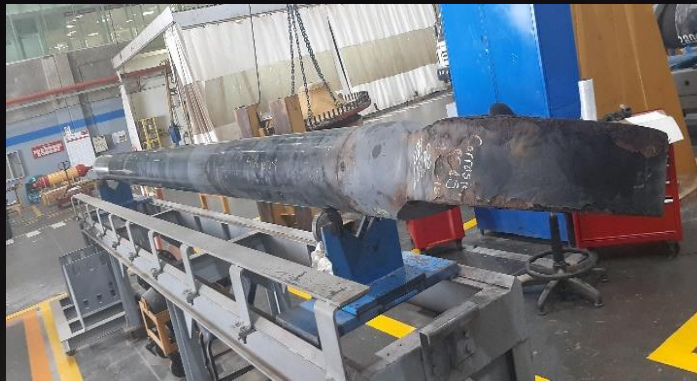
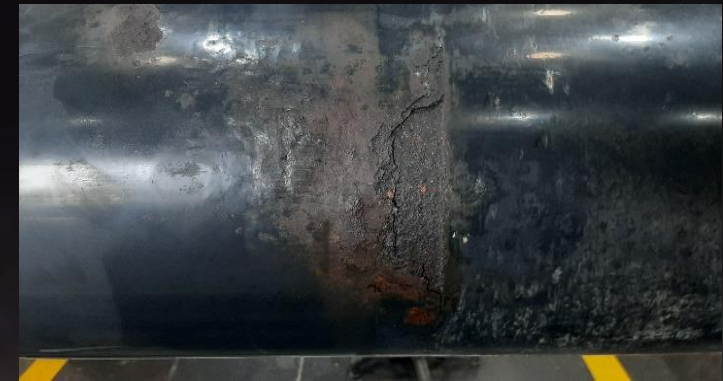
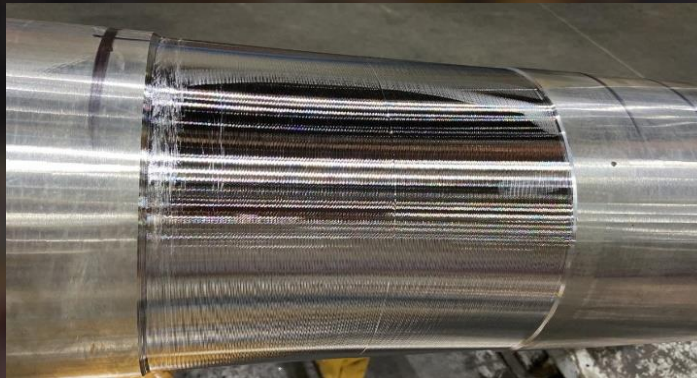
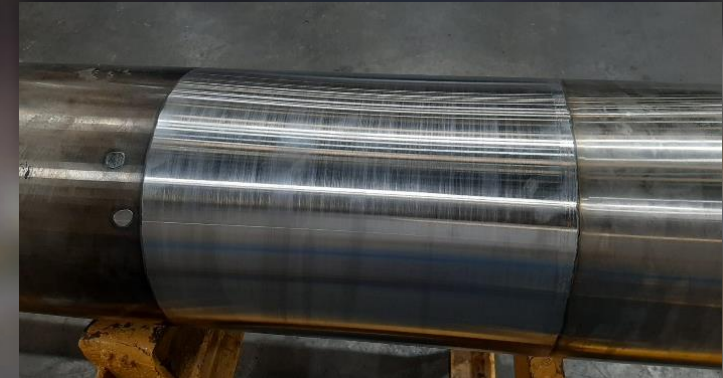
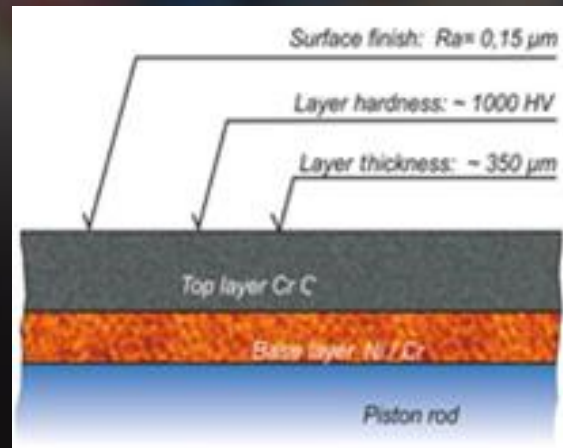
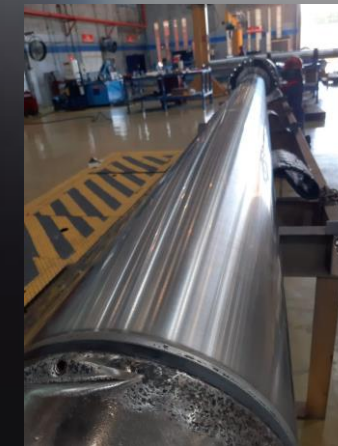
Extensión de Vida de los Componentes (Cerrejón - Puerto Bolivar)

COMPONENTE

Vástago Grúa
LUFFING

ESPESOR DE SALVAMENTO

650 Micrones

REVESTIMIENTO FINAL

75 CrC – 25 NiCr
0,7% porosidad
11.000 psi adhesión
1.100 VH

CAPA BASE

80 Ni– 20 Cr

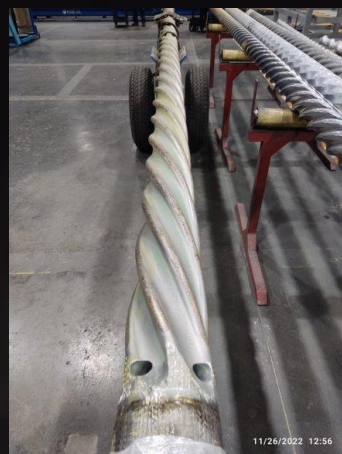
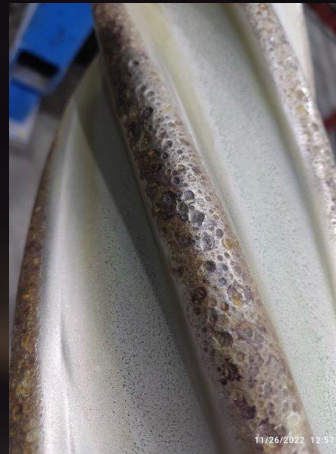
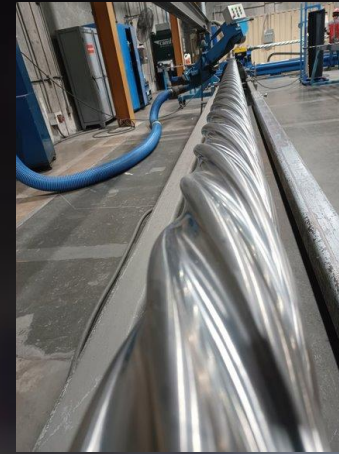
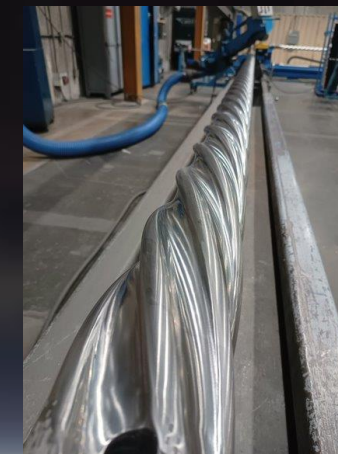
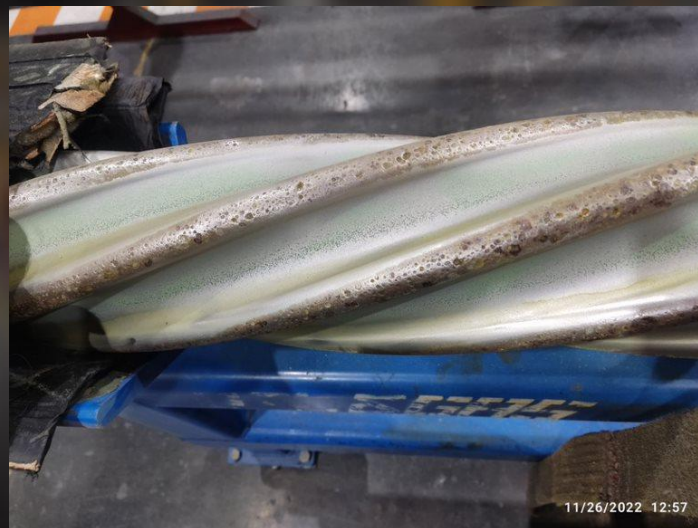
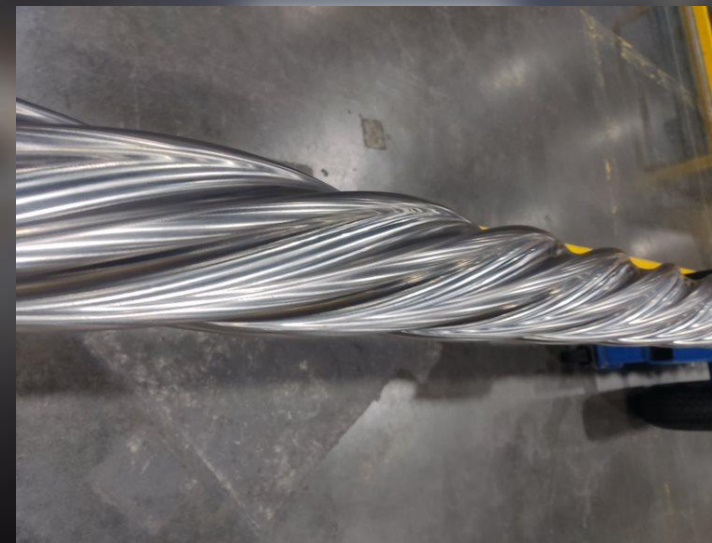
Extensión de Vida de los Componentes (Weatherford)

COMPONENTE

Rotor de Perforación
675

**ESPESOR DE
SALVAMENTO**

810 Micrones

REVESTIMIENTO

WC86 - 10 Co - 4Cr
0,5% porosidad
12.000 psi adhesión
1.300 VH

A N T E S

D E S P U E S

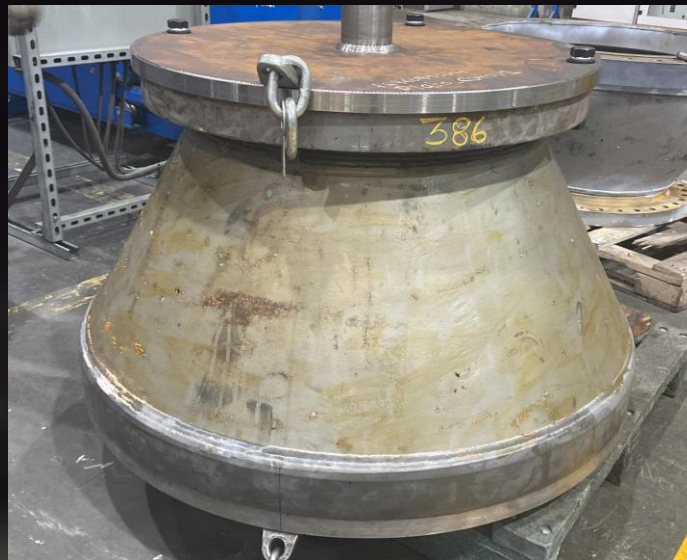
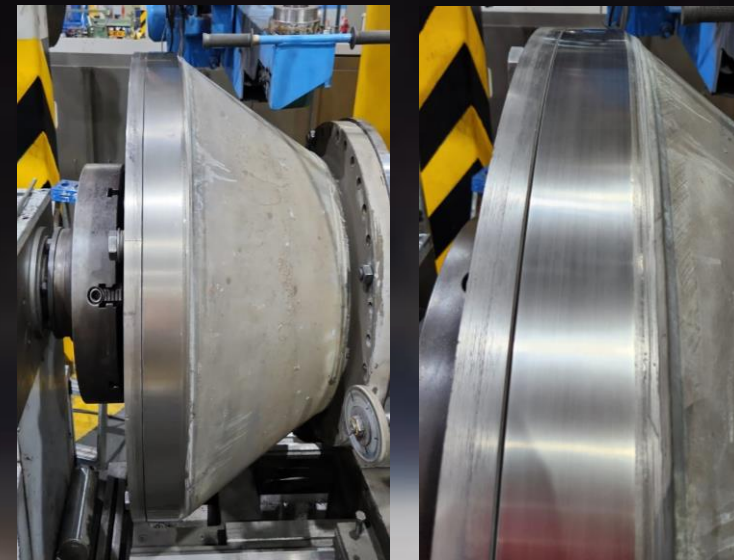
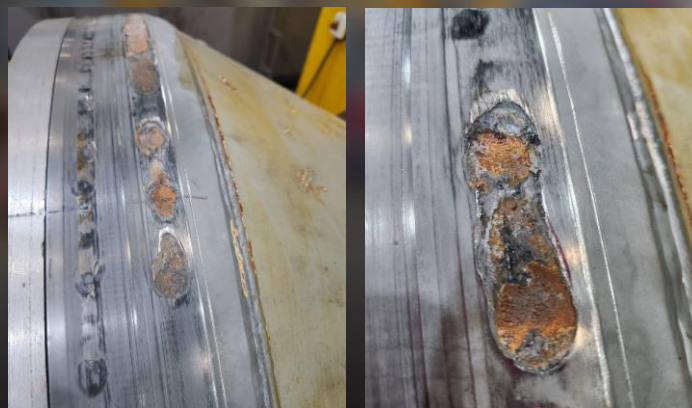
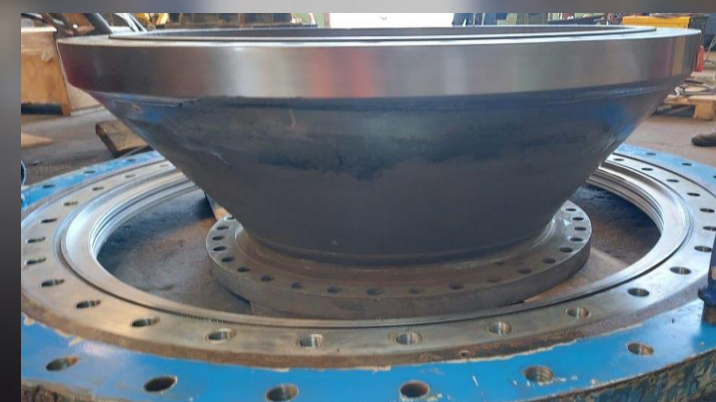
Recuperación de puesto sellado de CONOS AZIMUTALES (SVITZER)

COMPONENTE

Cono Azimutal
Remolcador
Modelo MS1781

**ESPESOR DE
SALVAMENTO**

700 Micrones

REVESTIMIENTO

75 CrC – 25 NiCr
0,7% porosidad
11.000 psi adhesión
1.100 VH

A N T E S

D E S P U E S

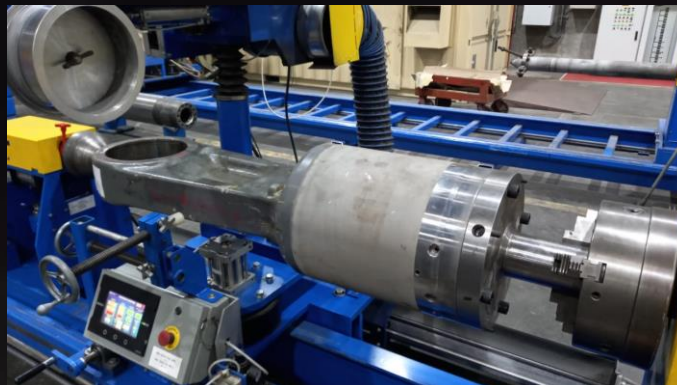
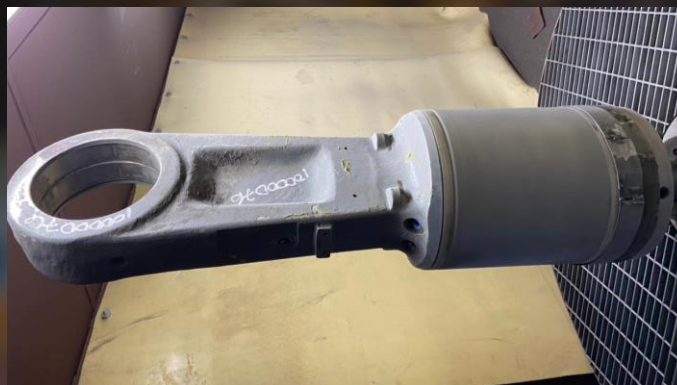
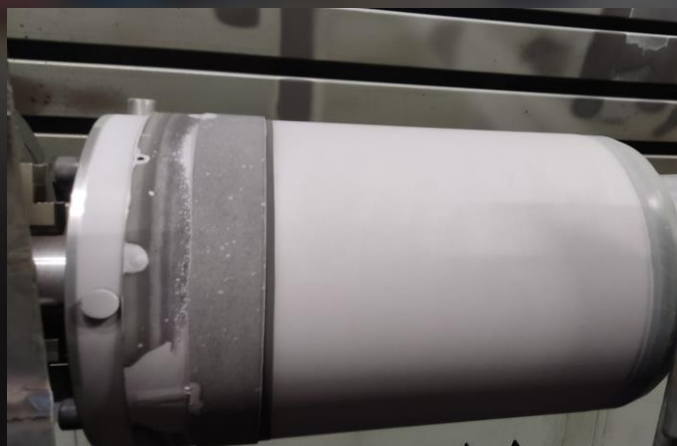
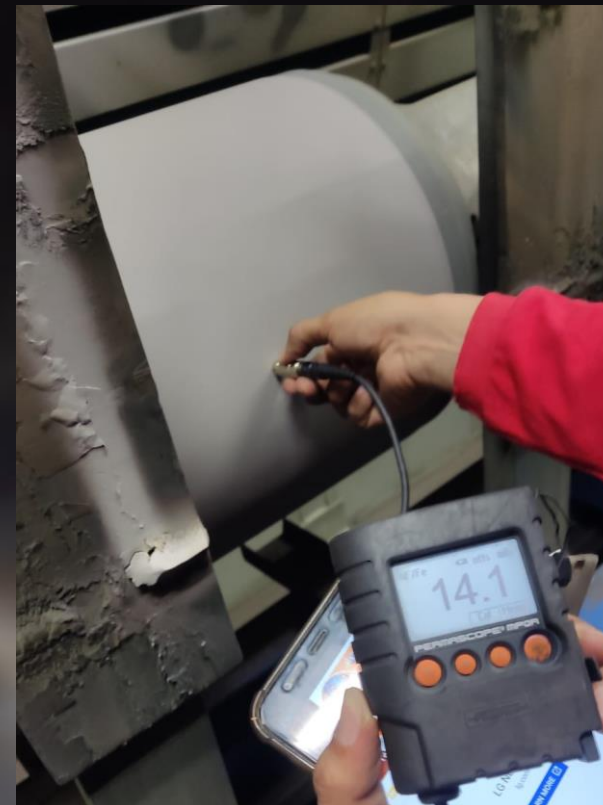
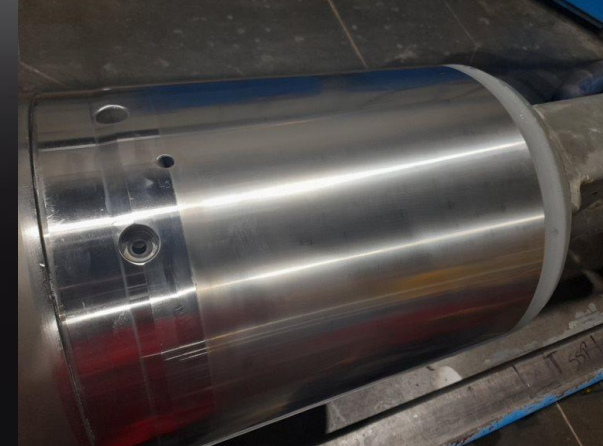
Extensión de Vida de los Componentes (First Quantum – Liebherr Panamá)

COMPONENTE

Vástago Suspensión
frontal camión T284

**ESPESOR DE
SALVAMENTO**

550 Micrones

REVESTIMIENTO

75 CrC – 25 NiCr

0,7% porosidad

11.000 psi adhesión

1.100 VH

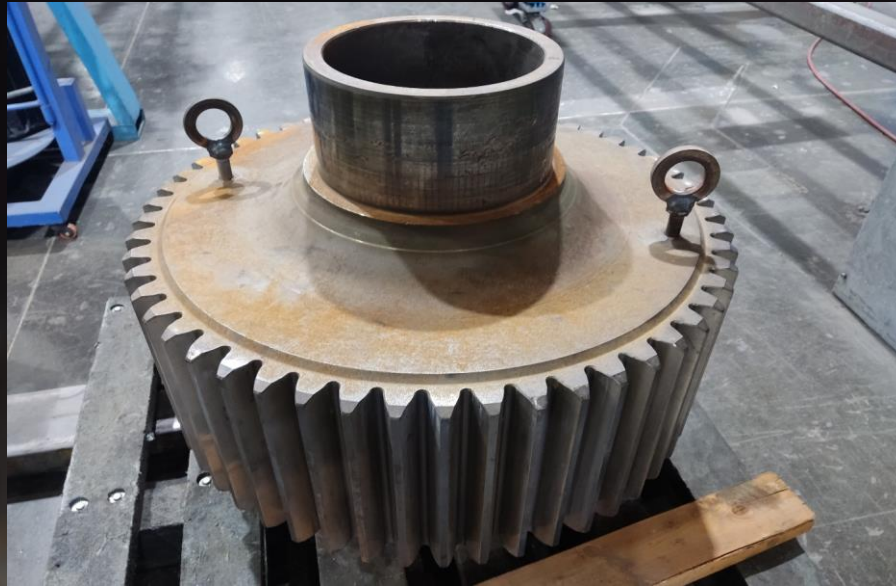
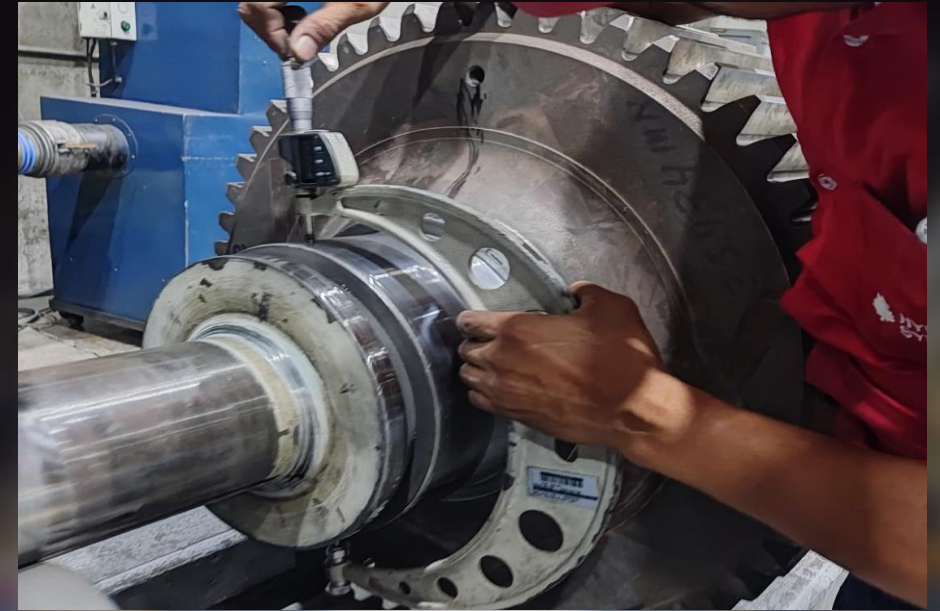
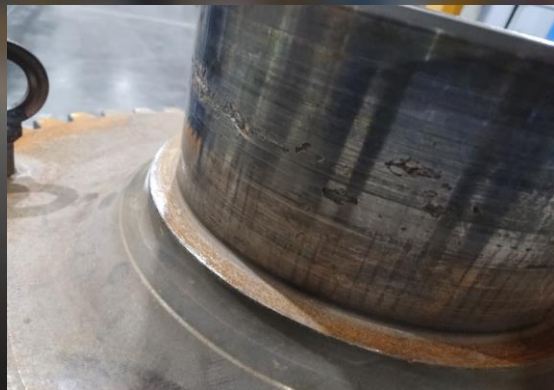
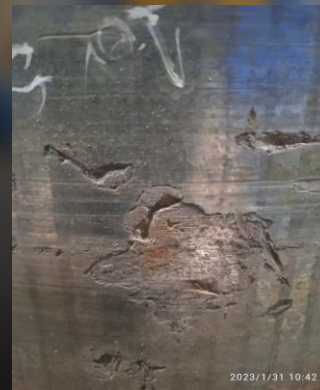
A N T E S

ESPESOR DE SALVAMENTO
500 – 550 Micras

REVESTIMIENTO
WC86 - 10 Co - 4Cr
0,5% porosidad
12.000 psi adhesión
1.300 VH

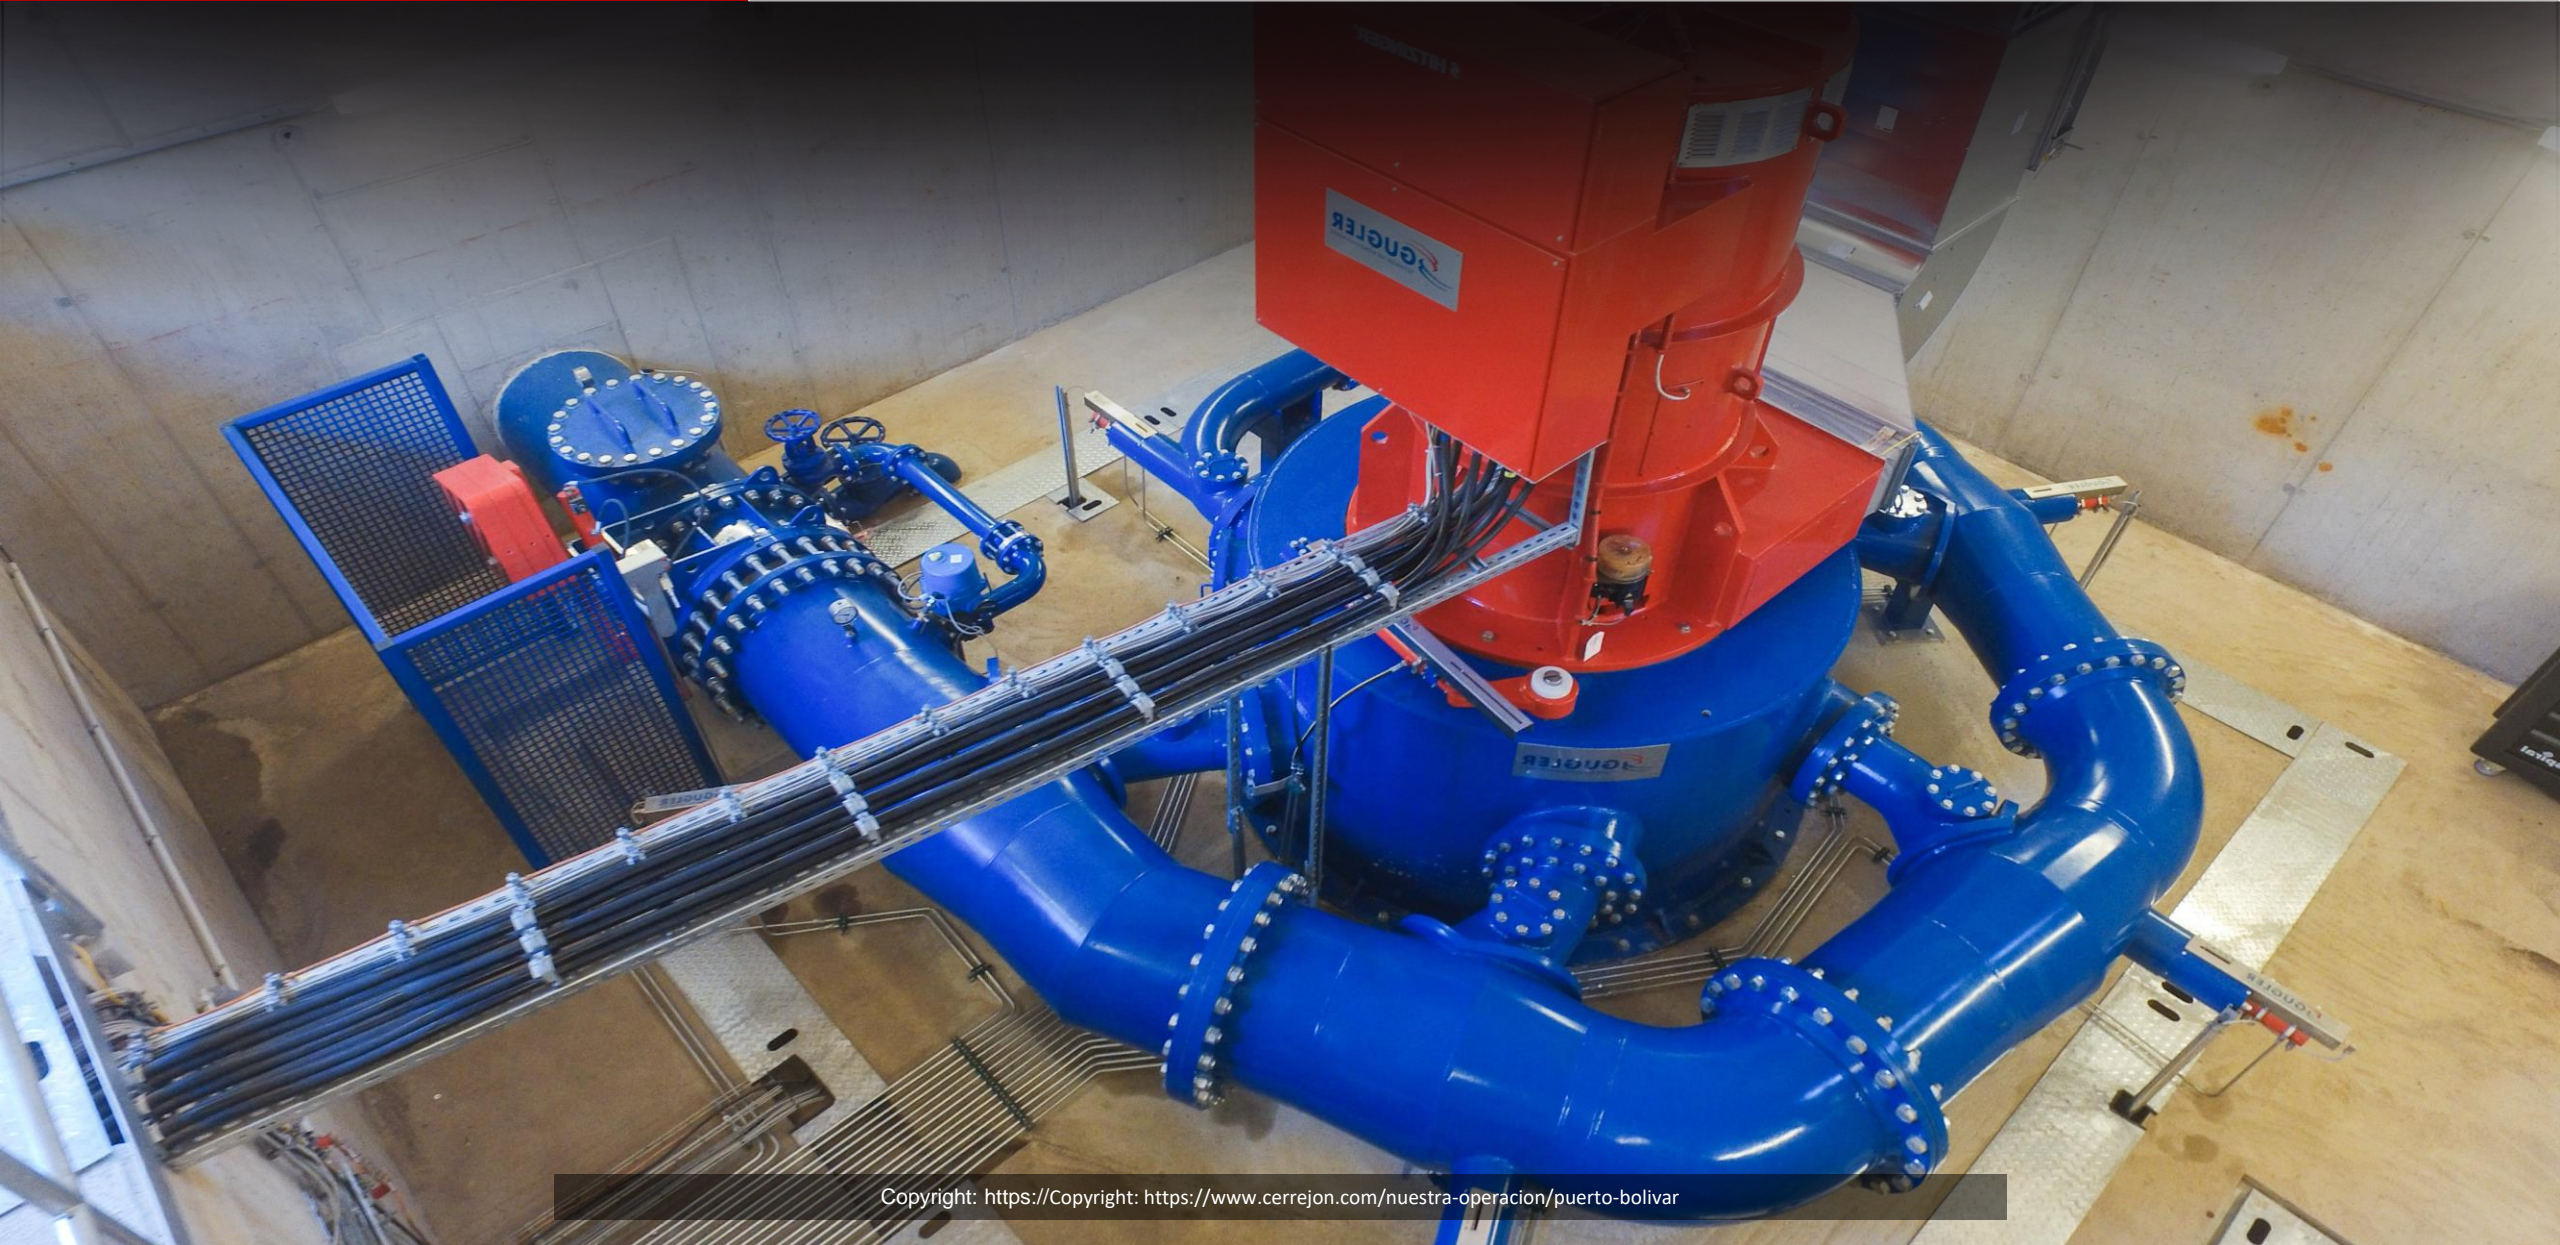
Reparación de Agujas y Boquereles de turbinas Pelton

Aguja y Boquereles
Sistema inyección
Turbina Pelton

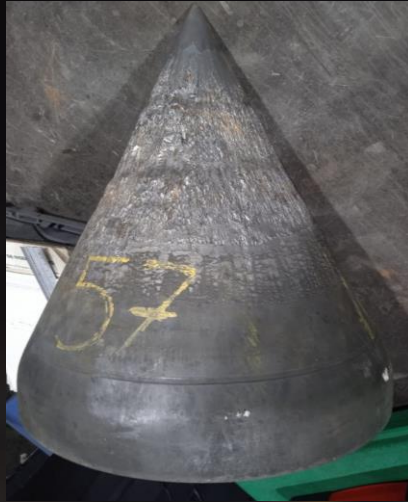
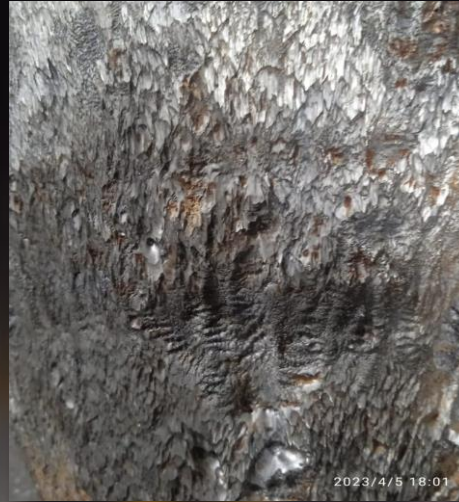
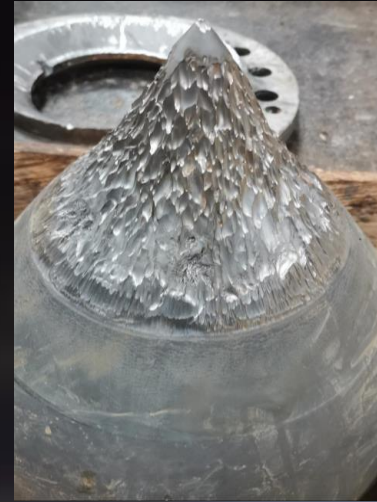
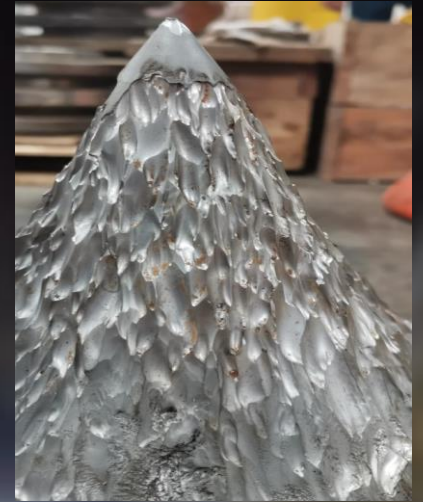
A
N
T
E
S

500 - 800 Micras

WC86 - 10 Co - 4Cr
0,5% porosidad
12.000 psi adhesión
1.300 VH

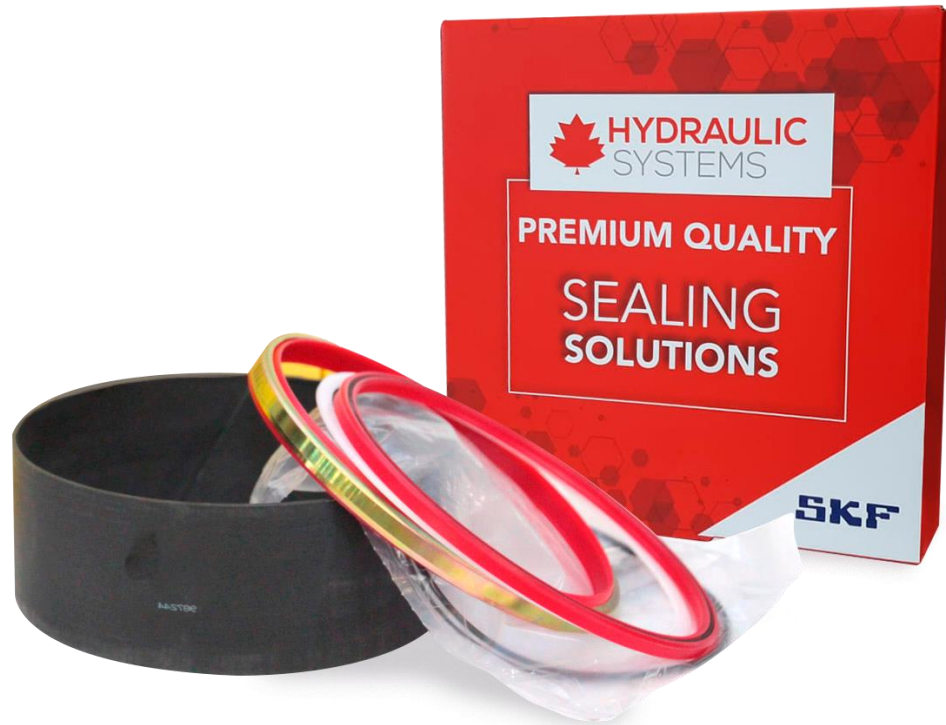
Las soluciones para la fabricación de sellos a la medida a través de la tecnología SEALJET de SKF, NOS PREMITE OFRECER + Soporte a nuestros clientes de todos los sectores, con los siguientes valores agregados:

1. Reducción en tiempo de fabricación y entrega.
2. Gran eficiencia de sellado con un mínimo de fricción y desgaste.
3. Extensión de la vida útil de los componentes.
4. Se puede fabricar sellos de casi cualquier perfil y tamaño.
5. Fabricación de sellos de geometría compleja.

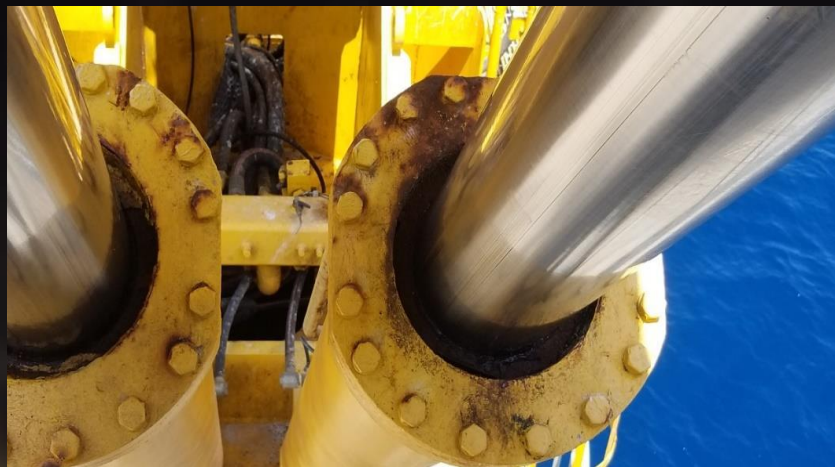
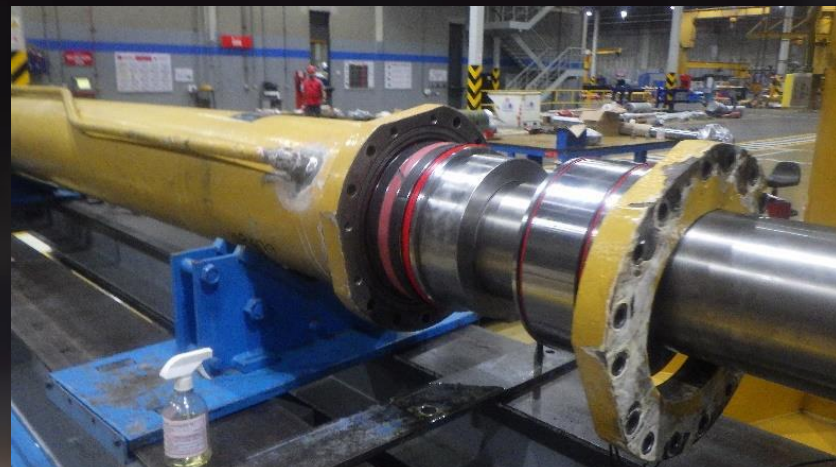
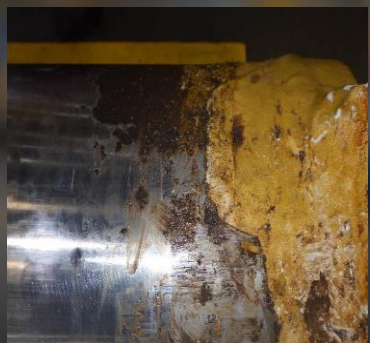
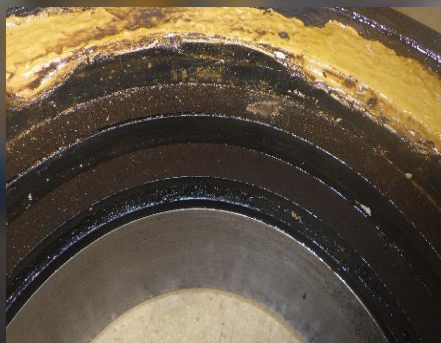
A N T E S

Cilindro Levante Boom

Grúa Nautilus –
Plataforma Off-Shore

Reparación Global y
Suministro de Solución
de Sellado a la Medida
